Subject: Progress Report No. 16 (December 8, 2007, through January 19, 2008)  
Remedial Investigation and Feasibility Study  
Plainwell, Inc., Mill Property, Plainwell, Michigan

**Progress Report No. 16**  
**December 8, 2007, through January 19, 2008**

**Remedial Investigation and Feasibility Study**  
**Plainwell, Inc., Mill Property, Plainwell, Michigan**

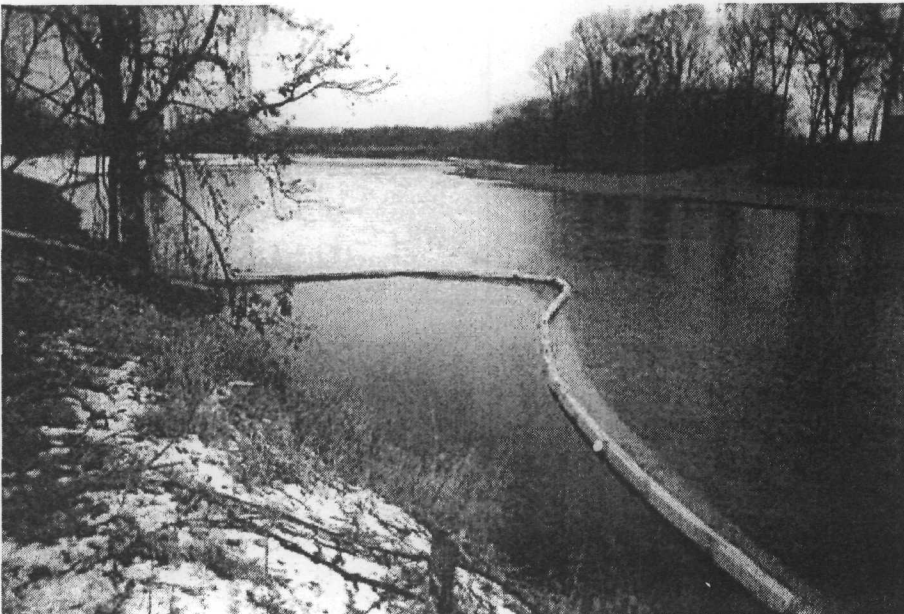
<b>Photo No.</b> <div style="text-align: center;">1</div>	<b>Date</b> <div style="text-align: center;">12/12/07</div>

<b>Description</b> Silt Curtain placement – Area B1

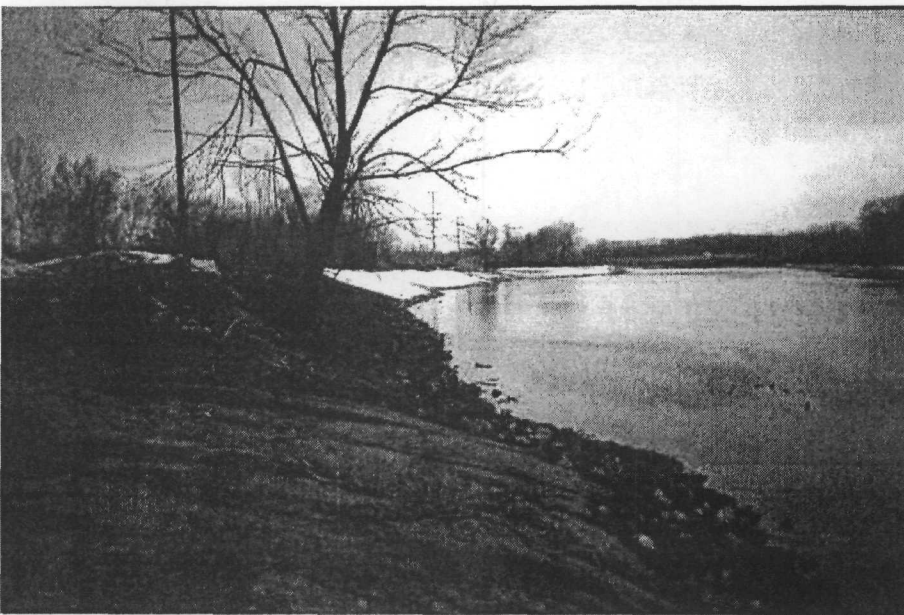
<b>Photo No.</b> <div style="text-align: center;">2</div>	<b>Date</b> <div style="text-align: center;">12/14/07</div>

<b>Description</b> Area B1 after restoring bank

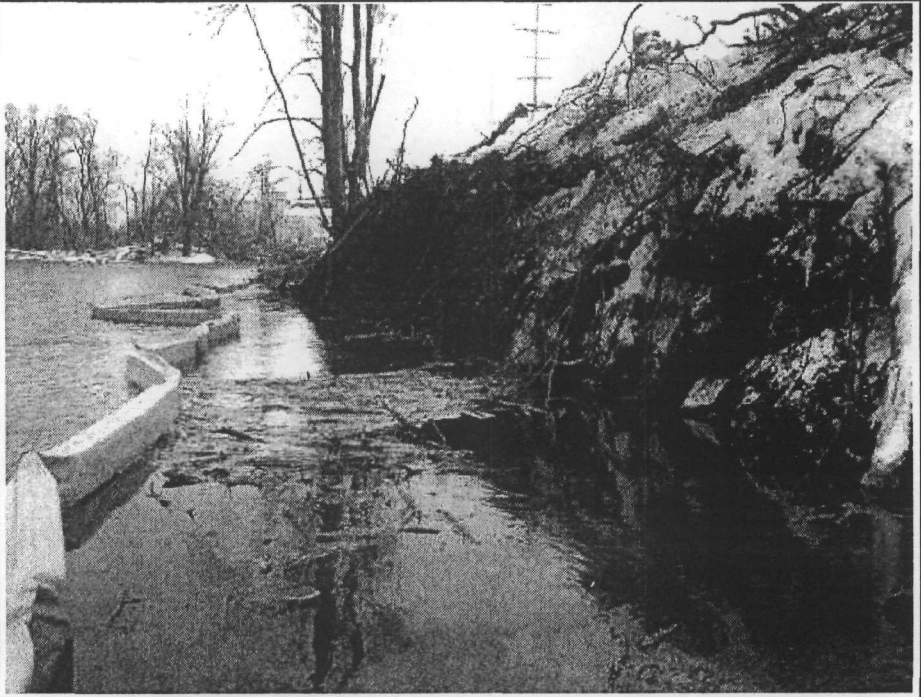
<b>Description</b> Area B-2 – removal of residuals at edge of bank			
<b>Photo No.</b> 4	<b>Date</b> 1/4/08

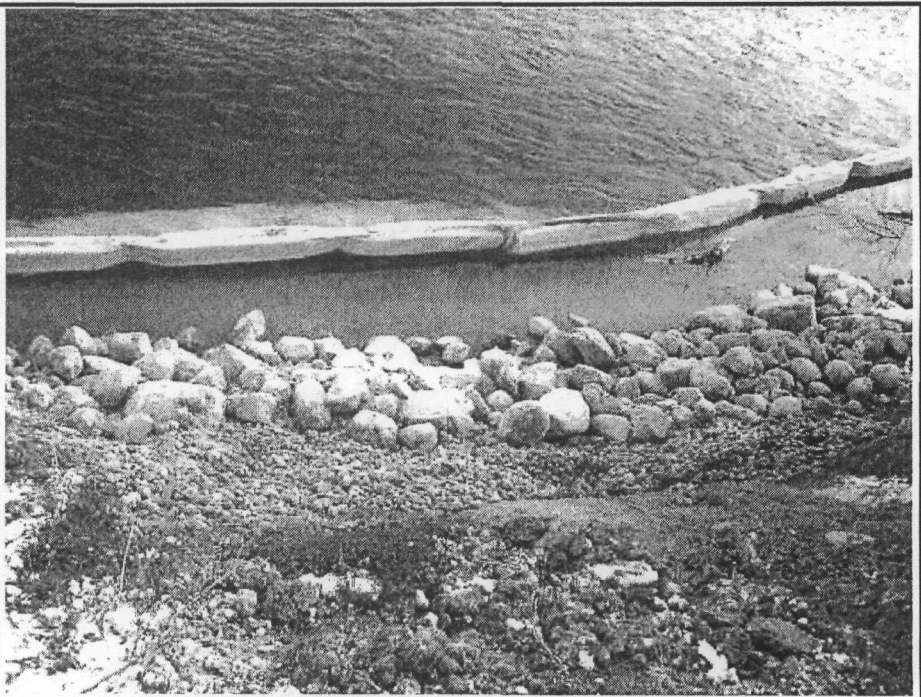
<b>Description</b> Area B-2 placement of gravel and rip rap stone along shoreline

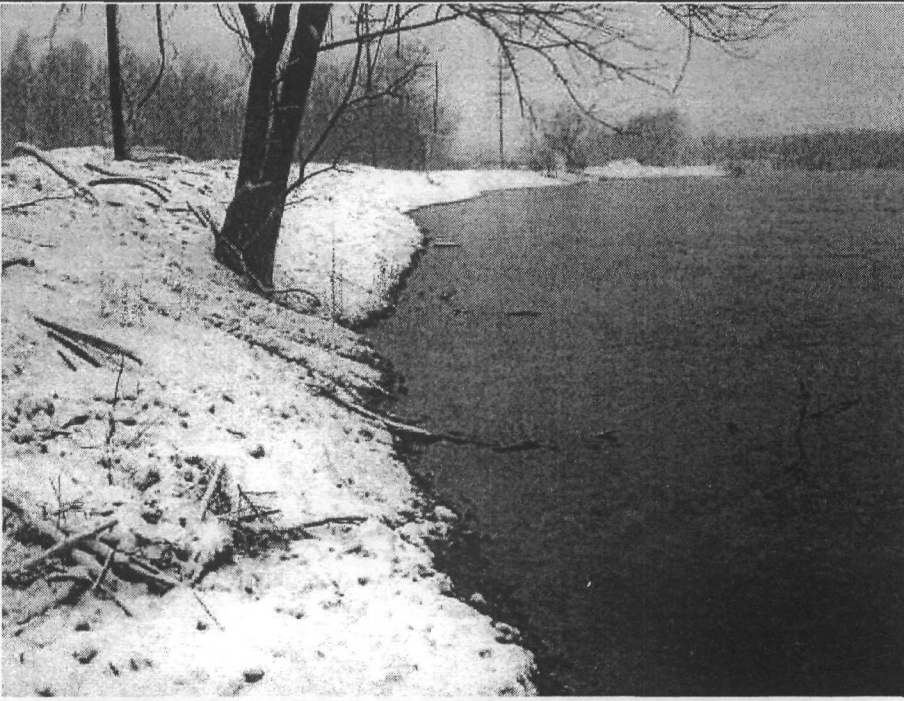
<b>Description</b> Restored bank Area A and B looking west			
<b>Photo No.</b> 6	<b>Date</b> 1/14/08

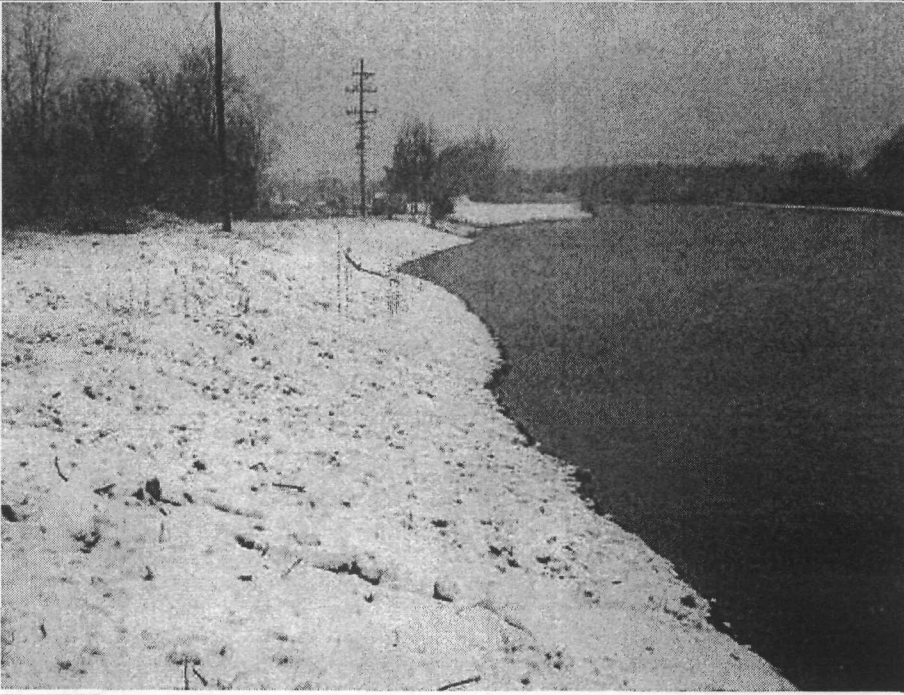
<b>Description</b> Restored bank Area A and B looking west
